Geotechnical Summary Report, Nicolaus Flood Risk Reduction Feasibility Project

Nicolaus Flood Risk Reduction Feasibility Project

Sutter County, CA
December 2, 2019

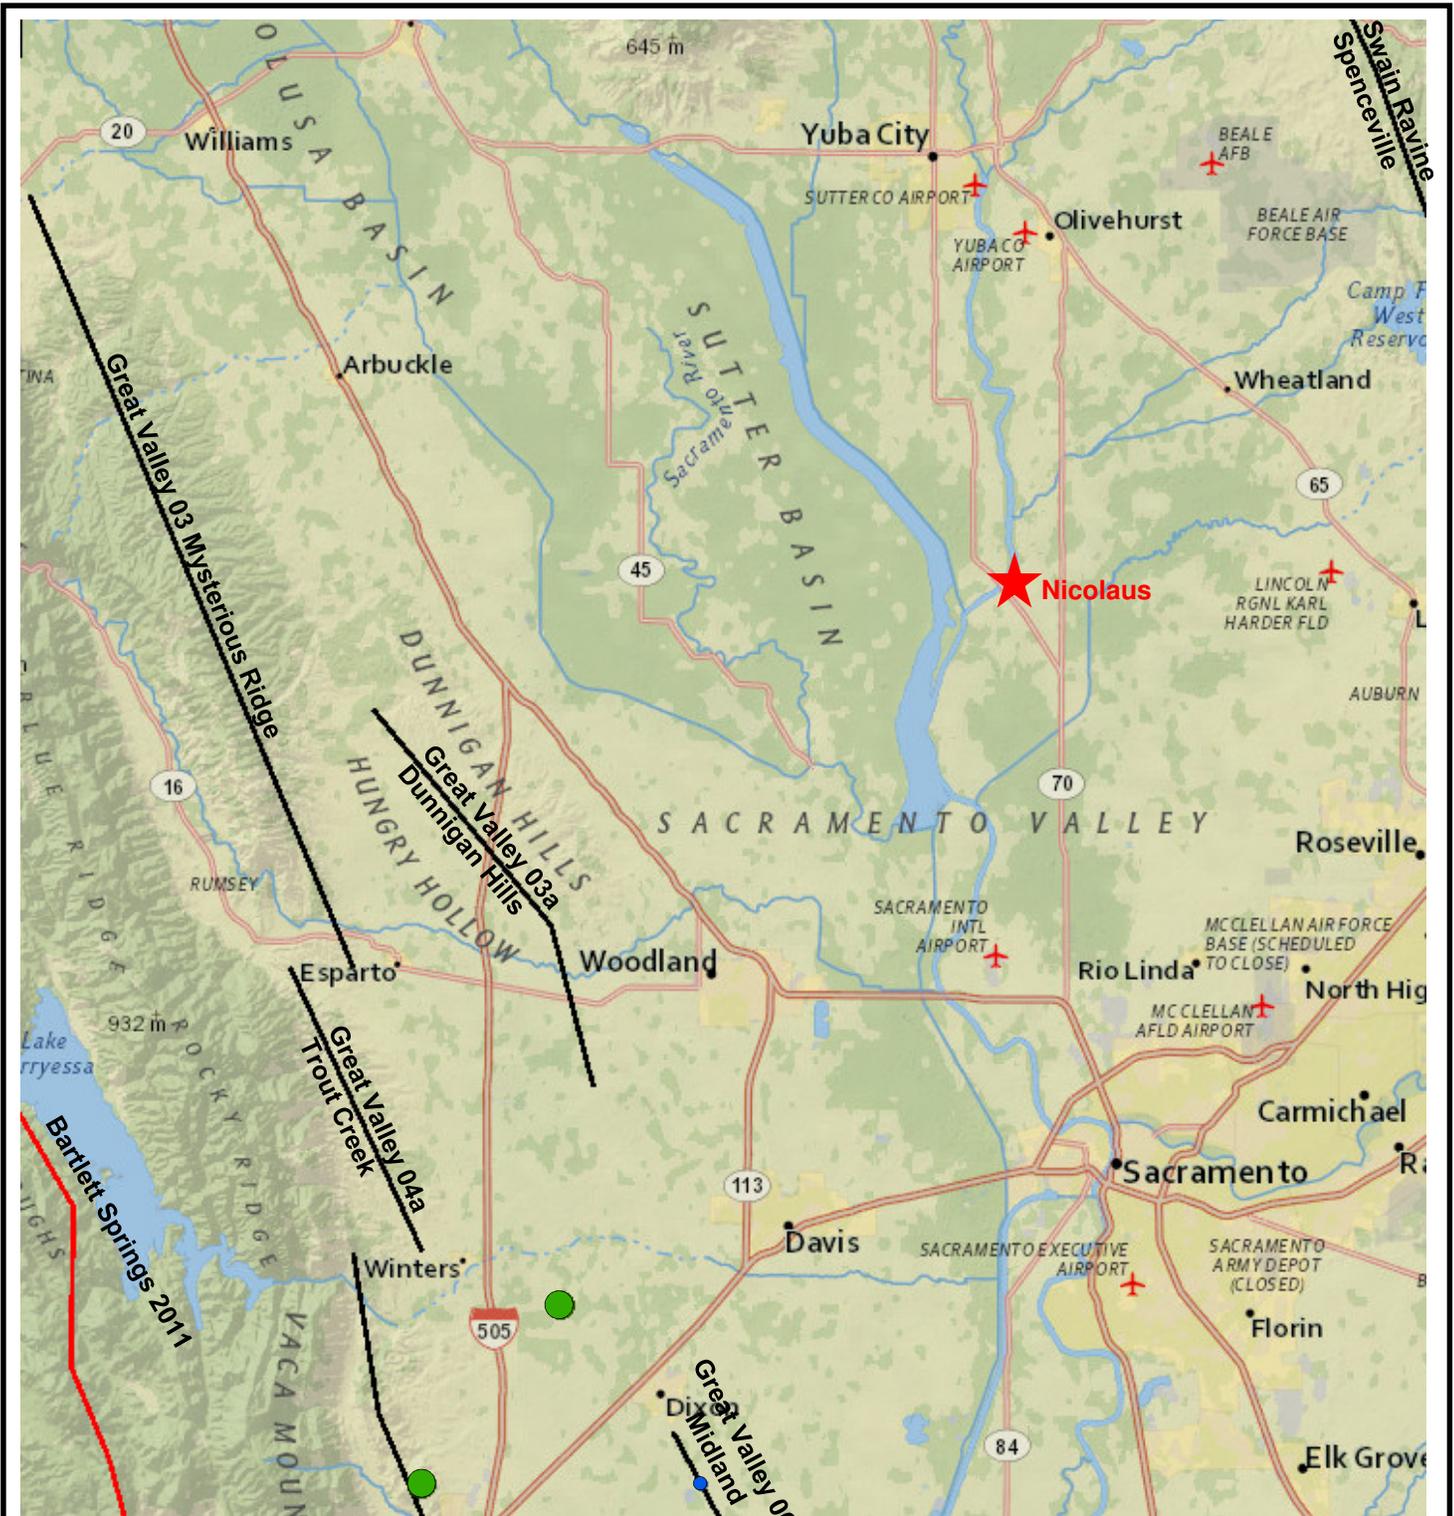
Fault Map
			July 2019 FIGURE 4

★ Project Location
● Historic Earthquake Magnitude 5-6
● Historic Earthquake Magnitude 6-7
 Thrust Fault
 Strike Slip Fault

The closest fault to the project within the GVFZ is the Dunnigan Hills Fault. The Dunnigan Hills fault is Quaternary active fault with a slip rate best estimate of 0.6 mm/yr and a maximum magnitude of 6.5 (Field et al., 2013). A fault map showing the project locations and earthquake events is included as Figure 4 – Fault Map.
